2013 Egg Survival Trial on the Ayr and Doon Catchments

Ayrshire Rivers Trust

Ayrshire Rivers Trust (ART) undertook egg box survival trials on two catchments during the winter of 2012/13. The purpose of these trials was to determine whether salmon egg survival was compromised in key locations in both catchments.

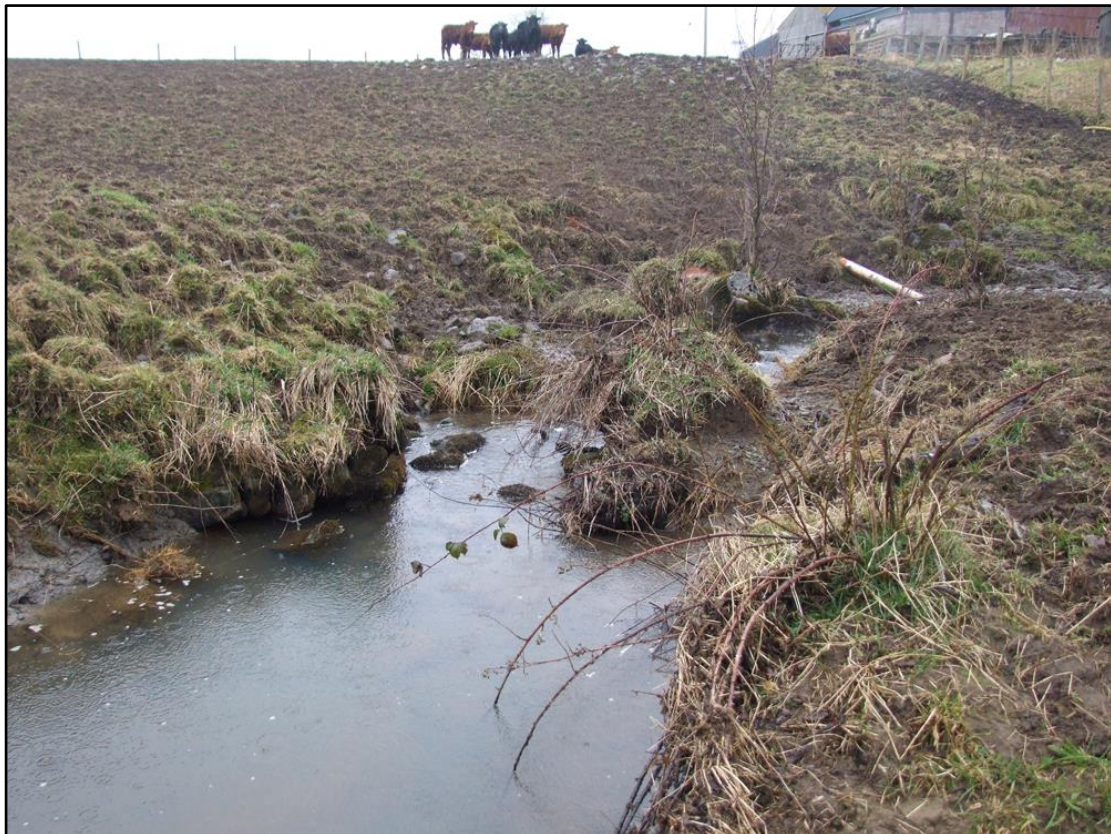
Agricultural and other inputs are targeted and many problems identified in walk over surveys, as demonstrated in figure 1. These surveys included all tributaries named on the 1:50000 OS Maps and results were summarised in a catchment wide map (figure 2) Follow up visits with landowners on a one to one basis were implemented on the Ayr catchment but have yet to be fully completed on the Doon due to staff constraints.

Figure 1: Netherton Burn where poaching by cattle leads to enrichment and siltation, reducing egg survival

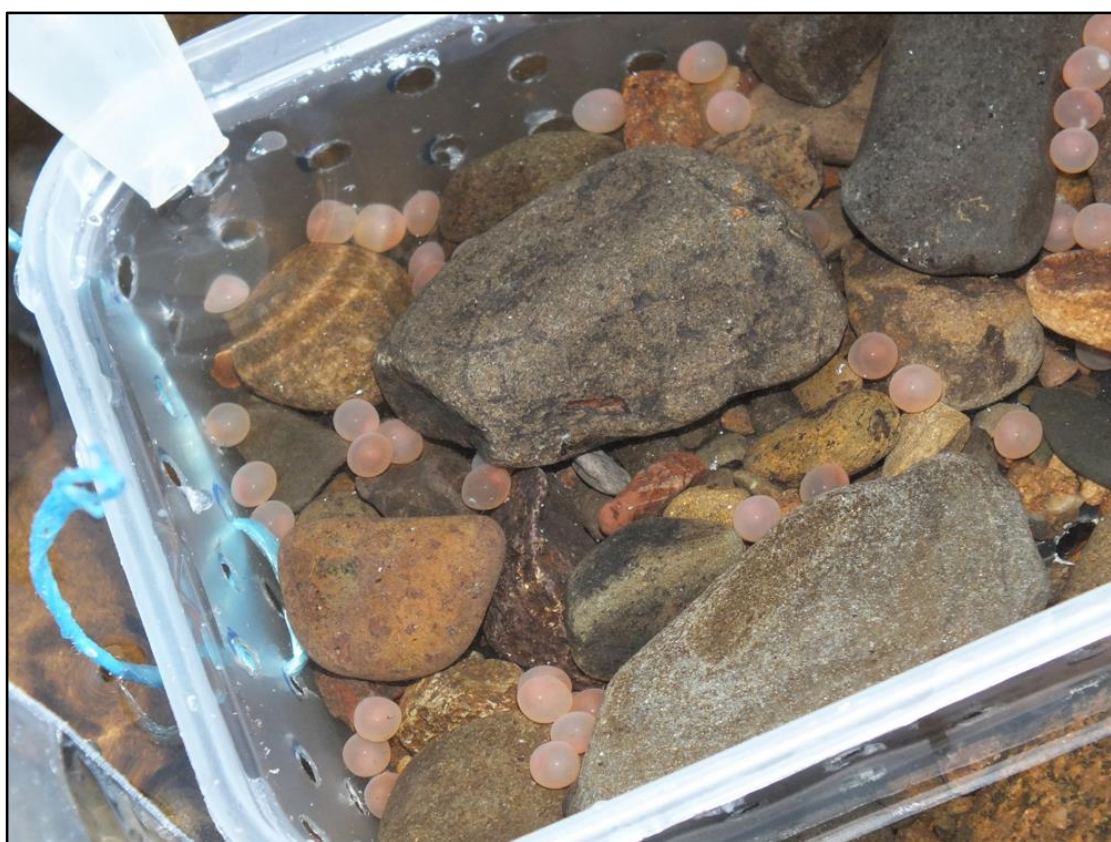
Figure 3: Eggs being gently placed in a box prior to burying in the riverbed

As seen in figure 3, river gravel was placed in each box and the eggs carefully added and the lid closed. Boxes were then buried carefully in redds created in the river using a fork to loosen the substrates and ensure free flow of water

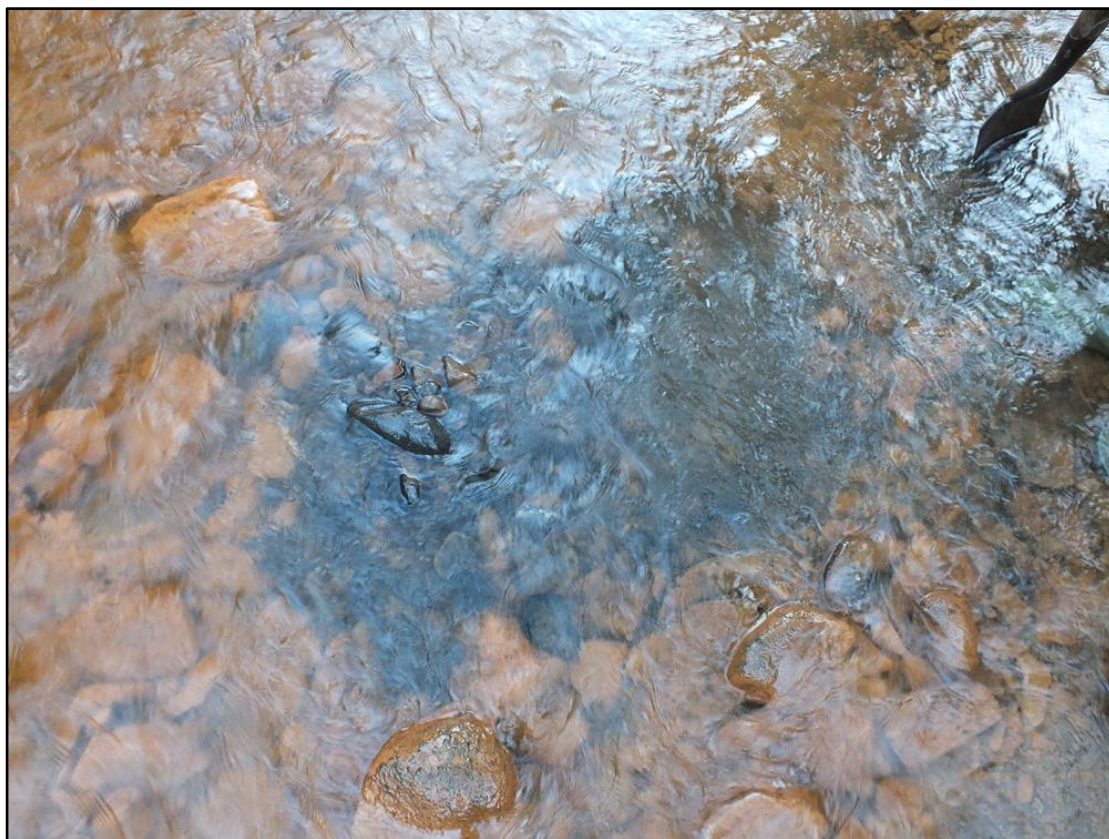
through each box (figure 4). Each box had a blue marker string attached to aid recovery at a later date.

Figure 4: Digging an artificial redd in the riverbed

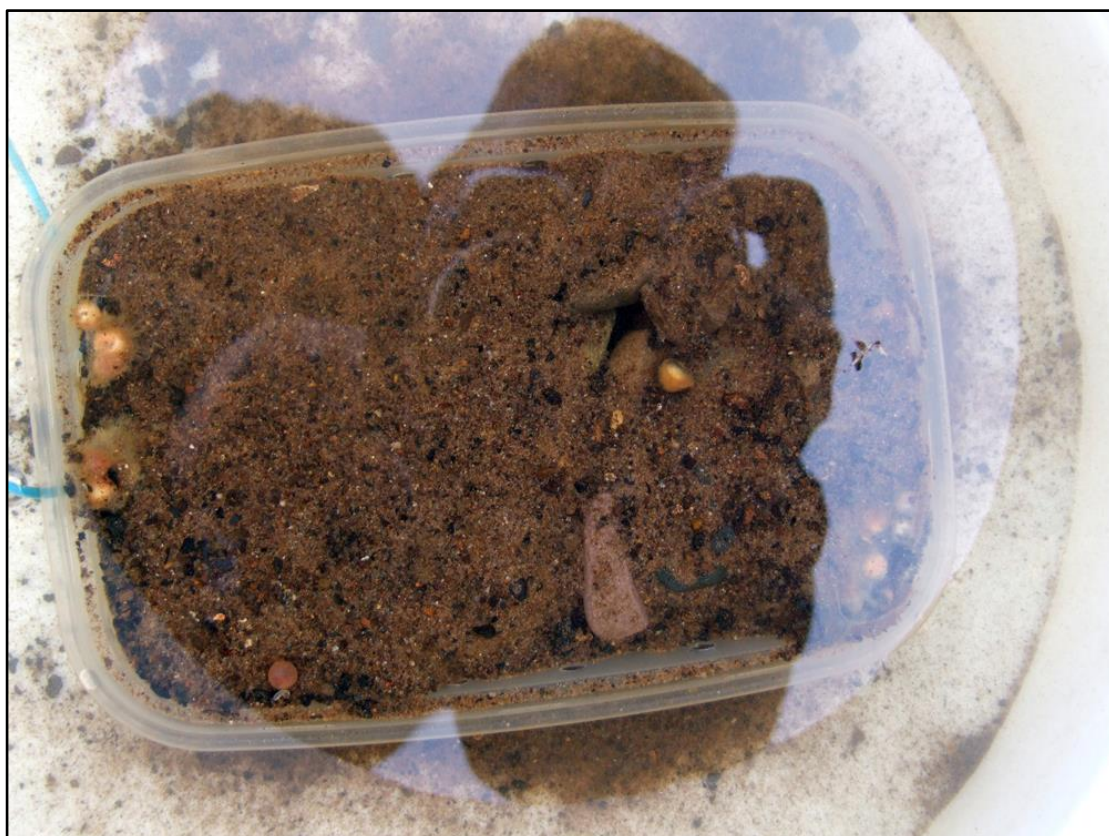
The next burn monitored downstream on the Lugar side of the catchment was the Back Burn (also known as the Ward Burn). High conductivity levels have been repeatedly recorded on this burn. It has also suffered from regular silt loading on occasions arising from a surface mine upstream. At the time of recovery, the flow through the area where the egg box was located was minimal, as water levels in the burn had reduced to a trickle due to a prolonged period of dry weather. The substrates in the burn were heavily coated with moss and algae and these trap silt. When opened the egg box was found to be heavily silted (figure 5). Egg survival after adjustment was 18.98%.

Figure 5: An egg box that was heavily silted

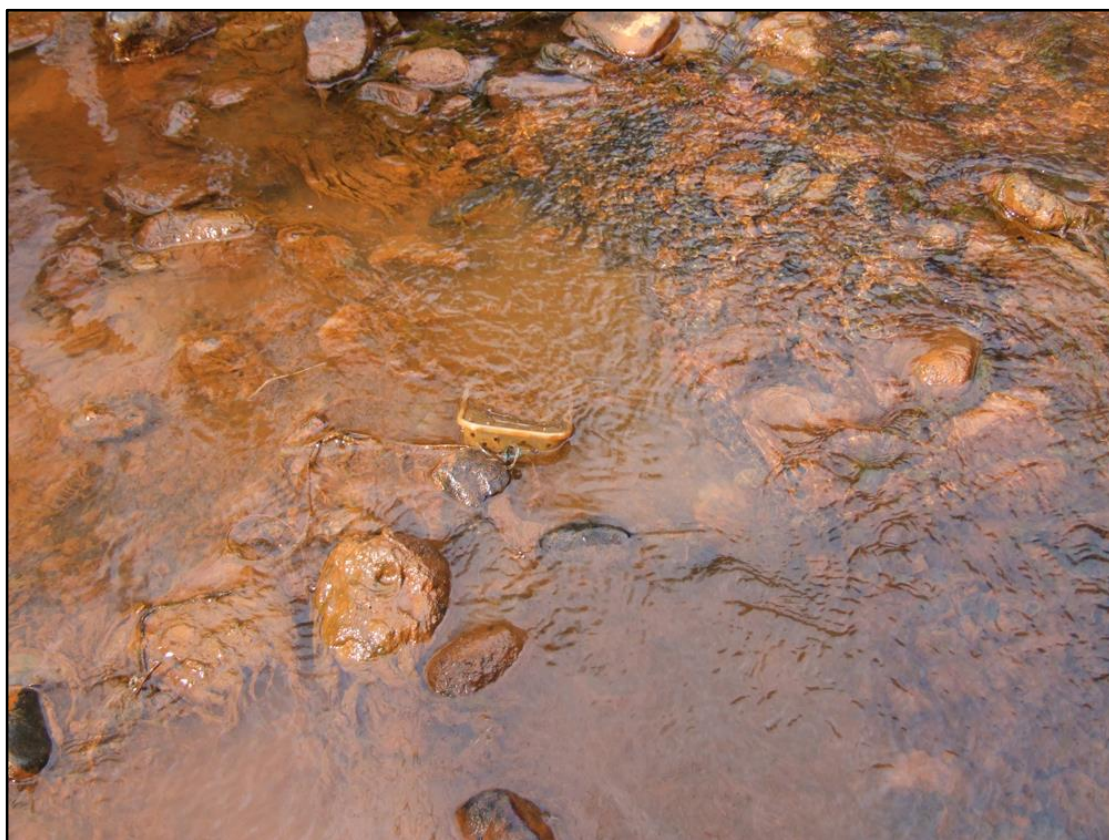
The Stottencleugh Burn is the source of the River Ayr. This burn flows into Glenbuck Loch which discharges through a redundant sluice gate to the River Ayr. The Stottencleugh is affected by both current and historic mining and is reputed to receive upwelling ground water from redundant mine shafts in the area. Settlement ponds at the Ponesk and Spierslack surface mines discharge to this burn a short distance upstream of the loch. Further upstream above the current mining influences, the burn supports a healthy but isolated population of brown trout. Downstream of the mines the streambed is heavily coated with iron oxides deposited from the water column (see figure 6) and conductivity levels are high. Despite this, invertebrates can be found and late in the spawning season many trout can be witnessed attempting to lay eggs in this area. During late 2012, ART staff repeatedly witnessed new redds cut in the streambed. Egg survival in such conditions seemed unlikely hence the positioning of an egg box in this area. Once opened the box was found to have suffered 100% loss as no eggs survived.

Figure 6: Extracting the egg box from the Stottencleugh Burn

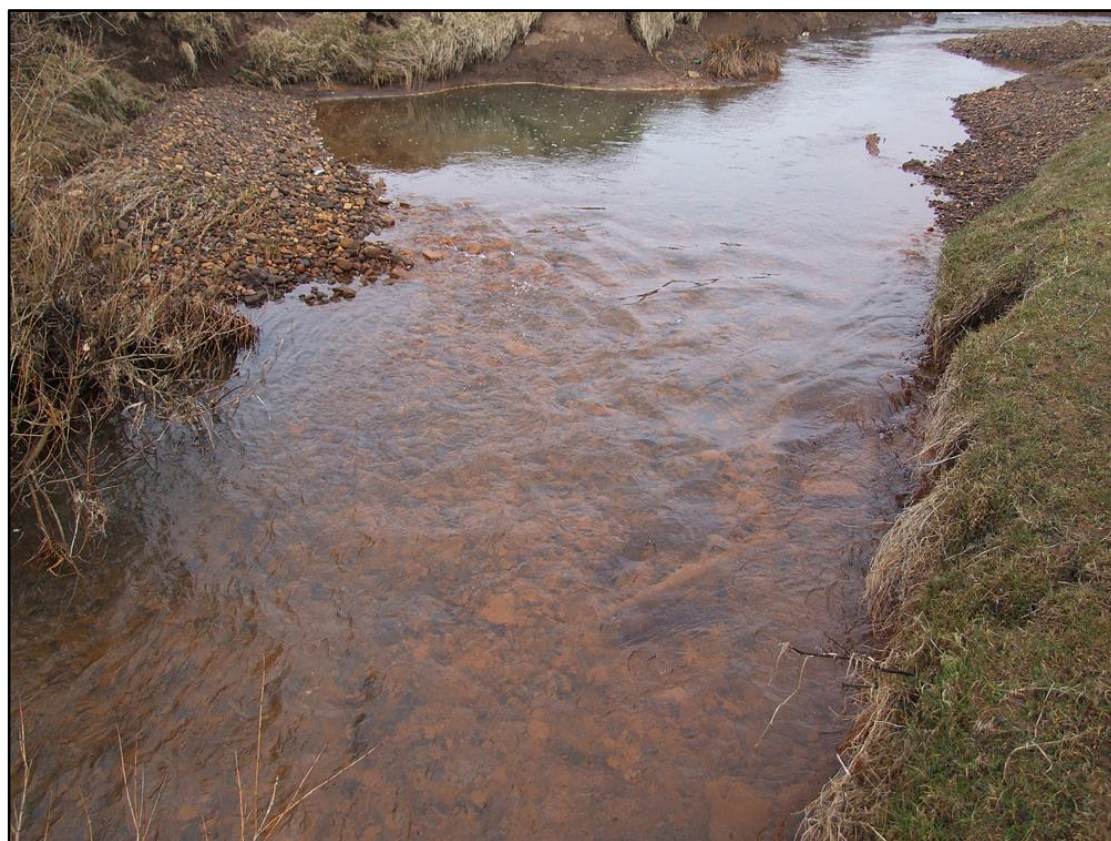
Further downstream at Upper Wellwood, the river was in poor condition with obvious enrichment and iron oxide present across the width of the riverbed (figure 7). This area has large quantities of gravel available for spawning however the condition of the substrates are very poor hence the selection of this site for egg box trials.

Figure 7: Good spawning material in poor condition as a result of enrichment

Water levels were low and the egg box was found to be above the water line in a gravel bank. Despite this the egg box was opened and surprisingly found to contain 24.05% viable eggs. It can only be assumed that the gravel within and surrounding the box remained adequately moist and oxygen was drawn from the atmosphere. The river level had been very low for several weeks.

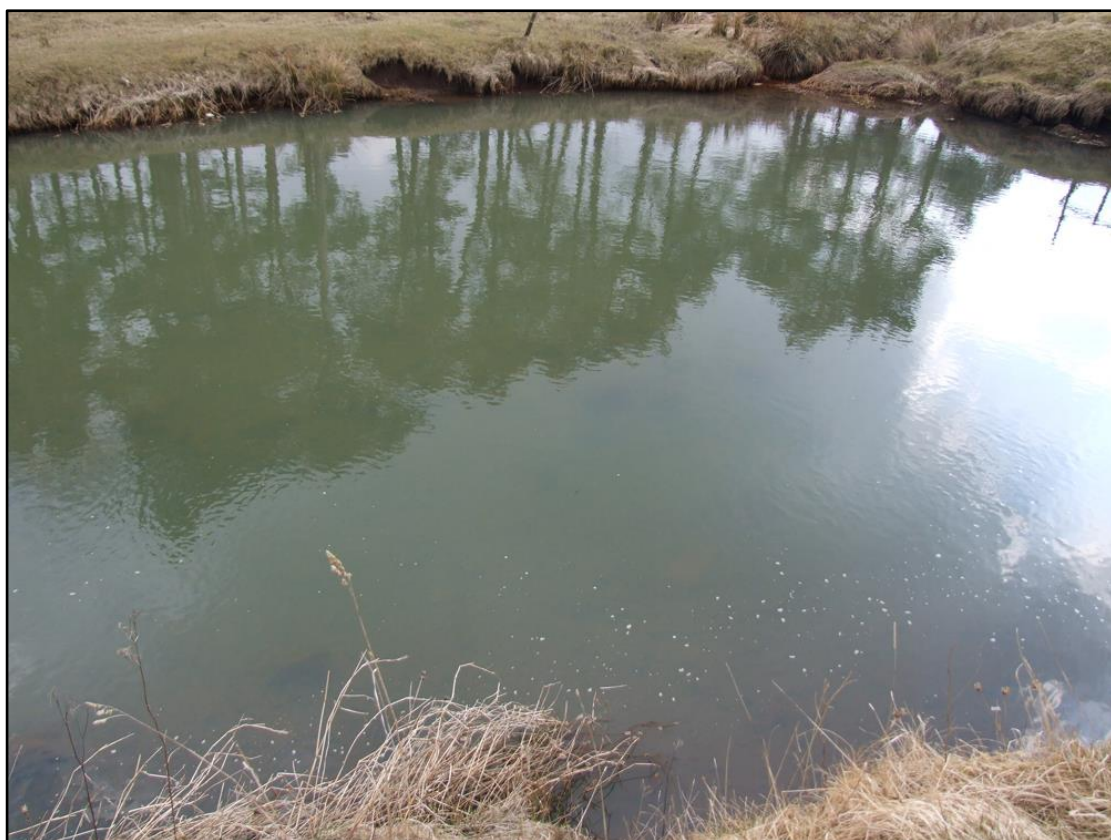
At Nether Wellwood the river again appeared to be in poor condition. This site is important for spawning and has been monitored by ART for several years over which a noticeable decline has been recorded in fry numbers. The egg box contained only 15 surviving eggs, which after adjustment calculated to an 18.98% survival rate. The substrates were coated with sediment and algae and the water was opaque and tinged green (figure 8), indicating enrichment.

Figure 8: Water quality at Nether Wellwood was poor

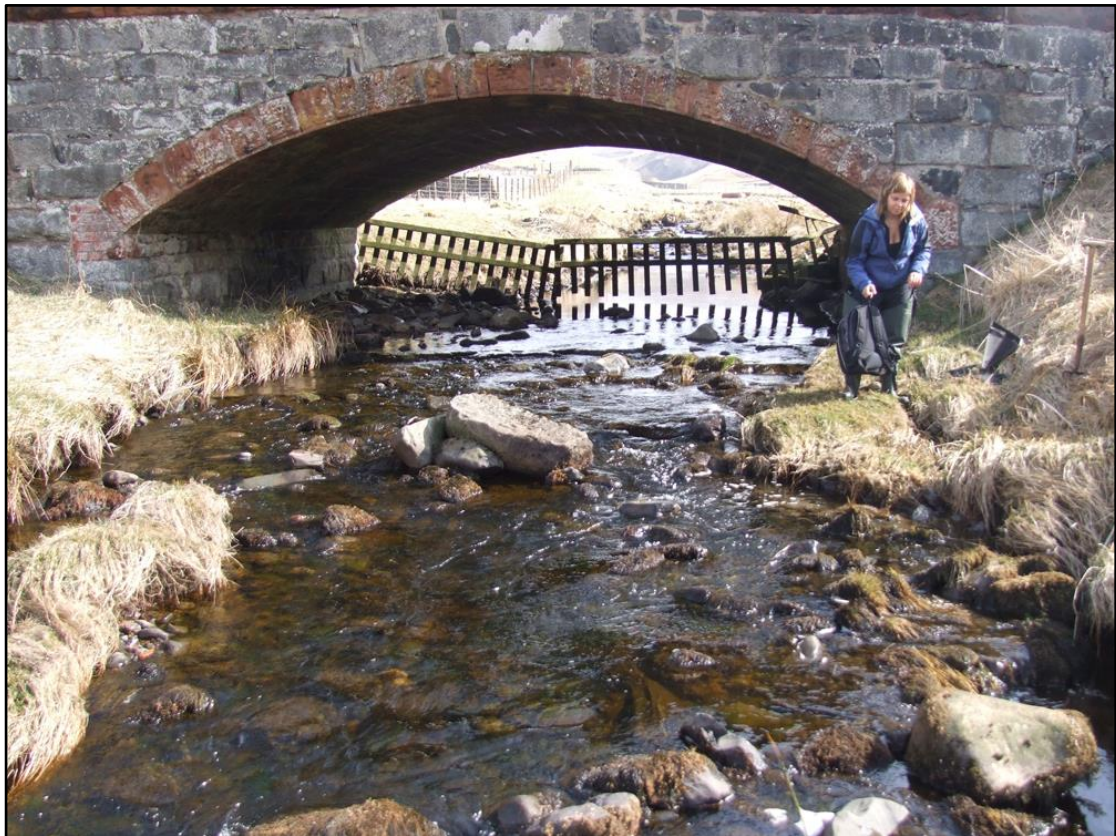
To ensure that comparisons could be drawn, a control site was chosen on the Mossdale Burn upstream of Dalmellington (figure 9). The site selected was away from all external influences other than forestry. Previously, egg trials in the upper Doon catchment indicated that 98 – 100% survival was possible where water quality is good. To allow assessment of the handling impact on the eggs to be determined, the results at the control site were taken to indicate 100% survival of undamaged and viable eggs and all results from across the catchment were calculated on this basis.

81 surviving eggs were removed from the Mossdale egg box and this was adjusted to represent 100% survival after taking account of handling losses.

Figure 9: The Mossdale Burn where egg survival was excellent

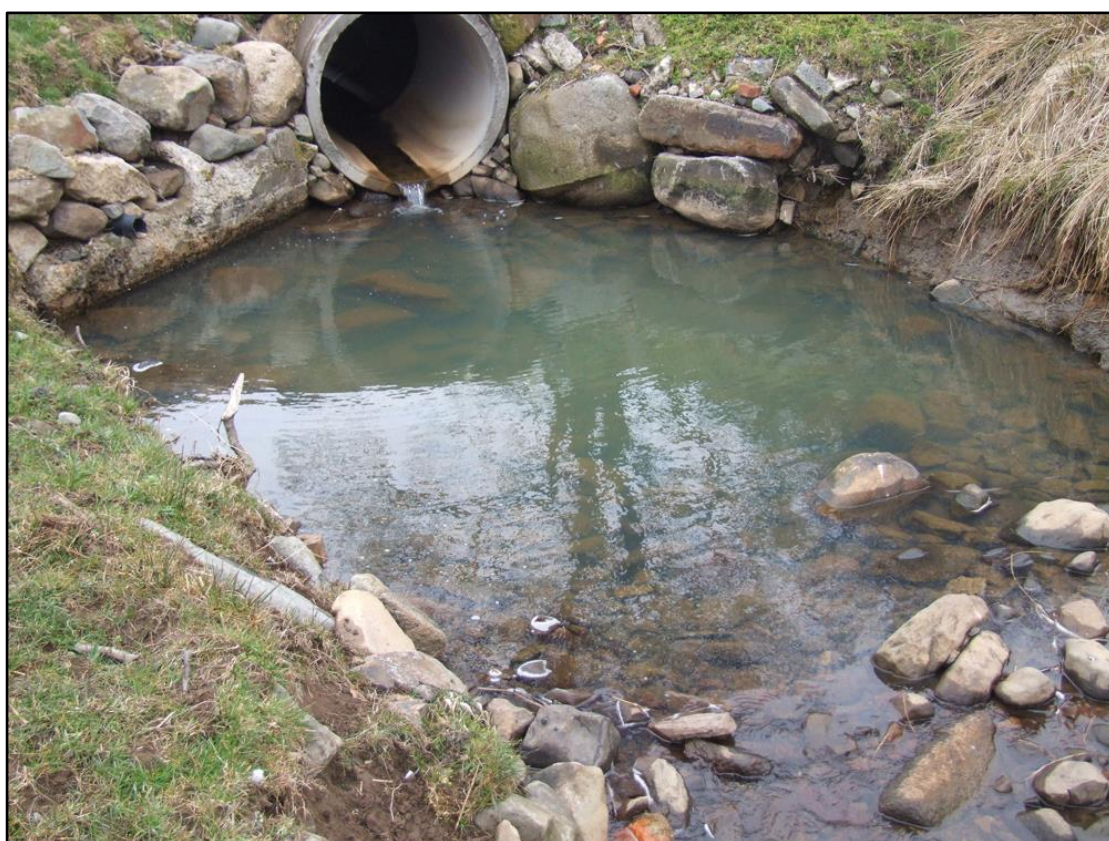
Boreland Burn also has limited access for migratory species but the lower reaches should provide good habitat for spawning. The burn downstream of the road culvert is accessible for migratory species. This area is unfenced and cattle and sheep are overwintered in the surrounding fields and have access to the burn. The streambed was covered in fined sediments and algae and the water was opaque indicating enrichment (figure 10). Egg survival was poor and calculated at 16.04%.

Figure 10: Water quality was poor on Boreland Burn

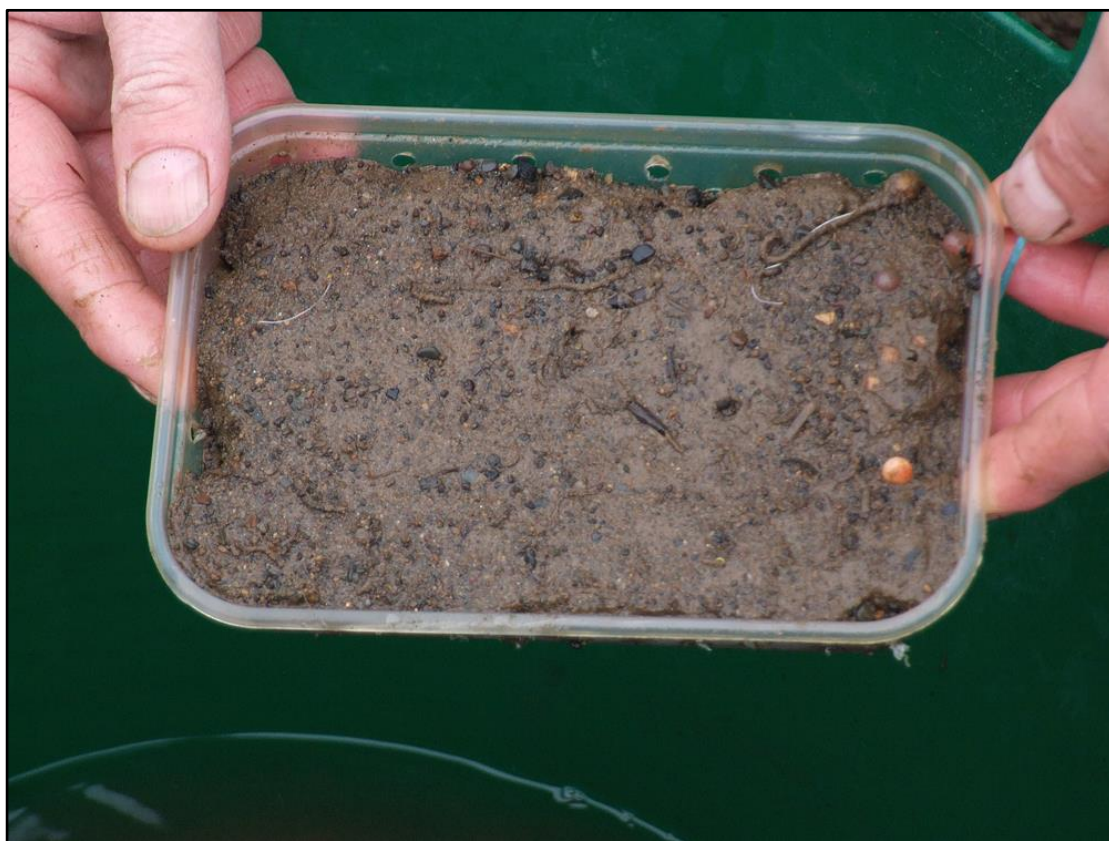
Another underperforming burn (and sub catchment) is the Chapelton Burn. ART found a single salmon fry in the Brockloch Burn during 2012. This indicates that migratory species still access the burn but probably in very low numbers. The Chapelton sub catchment has considerable potential for salmonid spawning and as a juvenile nursery but will require significant improvements to water and habitat quality. Intensive agriculture and road run off are thought to be the main factors currently limiting production however previous morphological alterations also contribute to the poor quality of the habitat. The egg trial site was downstream of the Brockloch confluence. At the time of planting, suitable substrates were impossible to locate due to the high volume of fine sediment on the riverbed. The best available habit was picked but on retrieval, the box was heavily silted (see figure 11) and no eggs survived.

Figure 11: A heavily silted egg box with poor survival

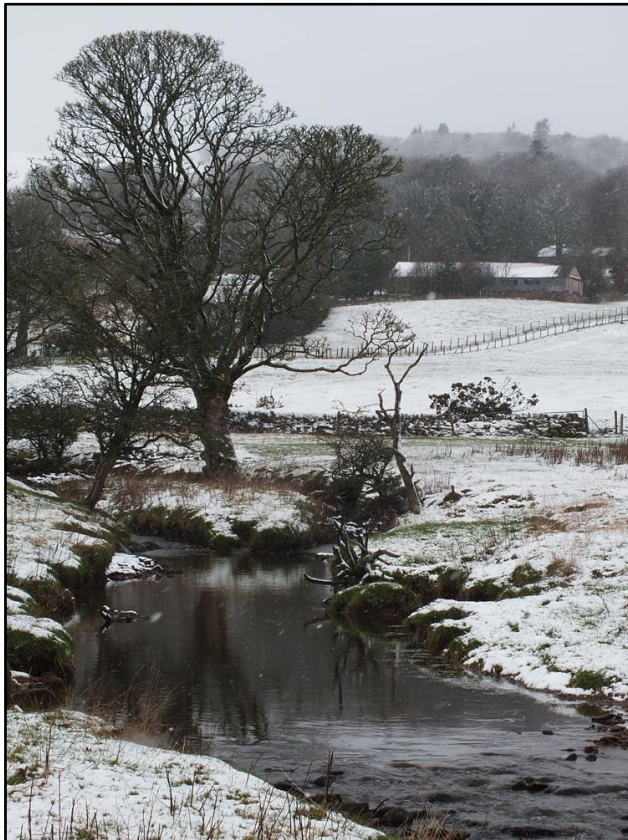
The Doon has few large tributaries and the Culroy Burn is perhaps the most significant with the greatest potential for recruitment. Until just a few years ago, the burn was regularly stocked by the DSFB with salmon and trout fry but this has failed to produce a sustainable population of consequence. There may be several reasons for this, however in order to assess egg survival, ART placed 3 boxes in the burn. The upper box was located high in the catchment at Sauchrie (figure 12). Overgrazing by sheep is obvious in this area but erosion doesn't appear to be excessive. Water quality appears to be good with a diverse range of invertebrates and virtually no siltation obvious. In such circumstances, egg

survival should be expected to be good unless other less obvious factors affect the burn. The results from the egg box were very poor at only 12.34% survival.

Figure 12: The Culroy Burn at Sauchrie

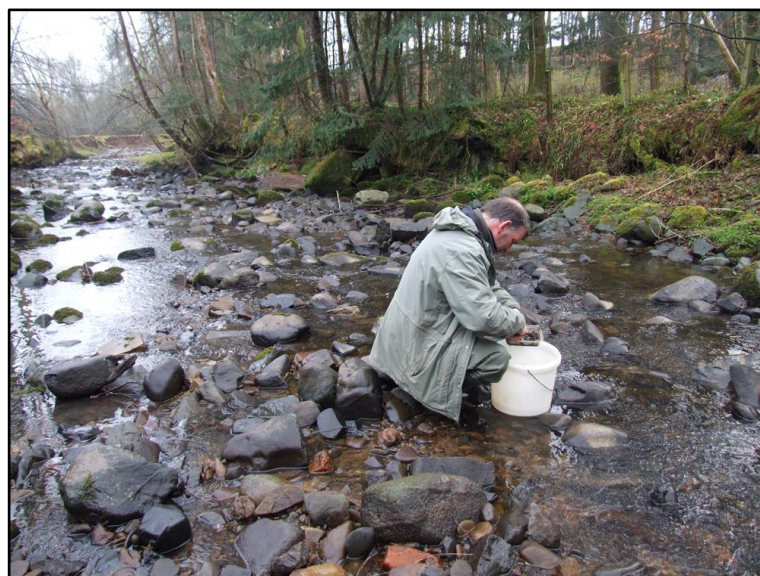
Downstream at Culroy, the habitat was again suitable for egg deposition and again a good result was anticipated. The result was poor with only a single egg surviving. ART has electrofished this area recently and found very low numbers of salmon surviving. The habitat provides an excellent juvenile nursery area (figure 13).

Figure 13: Habitat and water quality appeared good despite very poor results at Culroy
